# TECHNICAL REPORT

Coolant holes on Ajusa  
cylinder head gaskets

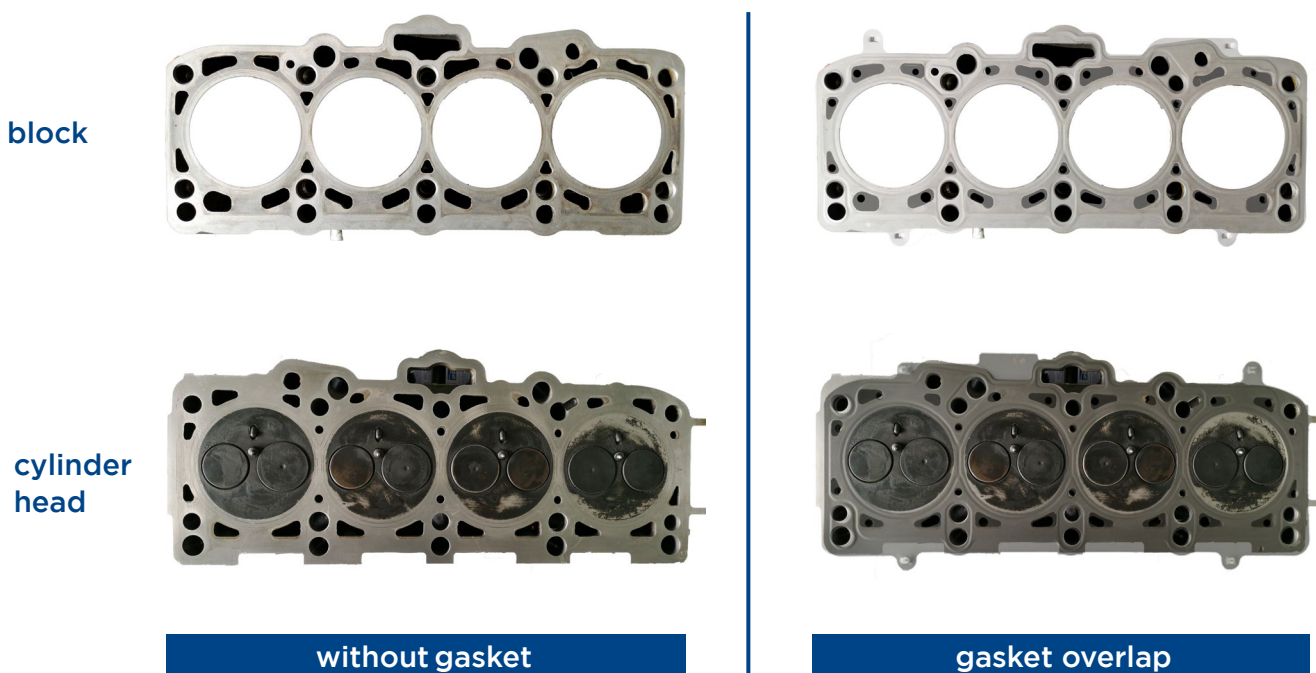
It is very common to find smaller sizes of coolant holes in the cylinder head gaskets, even sometimes they are misaligned or non-existent in relation to the cylinder head or block holes.

It is not caused by a production mistake or similar but have an intentional function: **maintaining optimum engine temperature.**

This way, the **flow of coolant** around the cylinders and through the cylinder head **is controlled**, regulating the temperature of the coolant avoiding overheating.

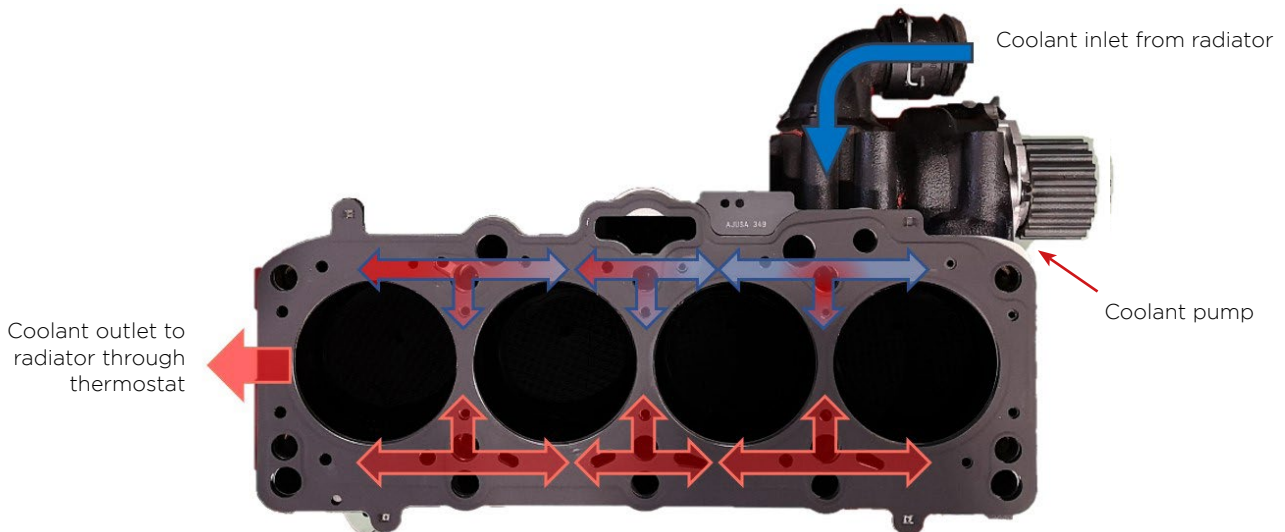
Engine **cooling must run** through the engine with **similar flow**, so it is necessary to reduce this flow near the water pump, where pressure is higher, it can be achieved reducing the holes on cylinder head gasket.

Coolant holes are **bigger away from the pump**, in these areas it is not necessary to hold coolant for so long given that pressure is lower because of loss of load in the fluid.

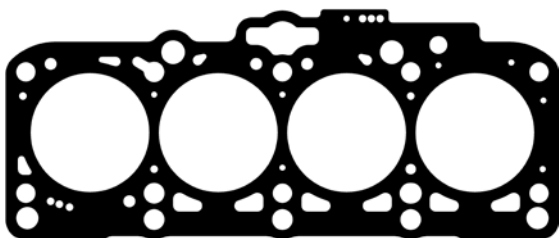
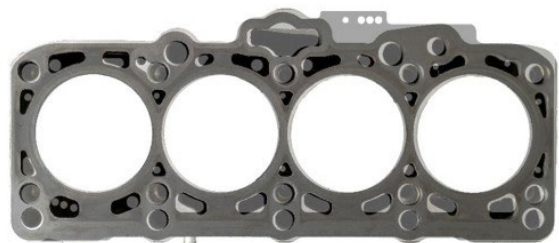
10121700 old design

It is probably that you can notice smaller holes when fitting Ajusa gasket. It happens as in the example below:

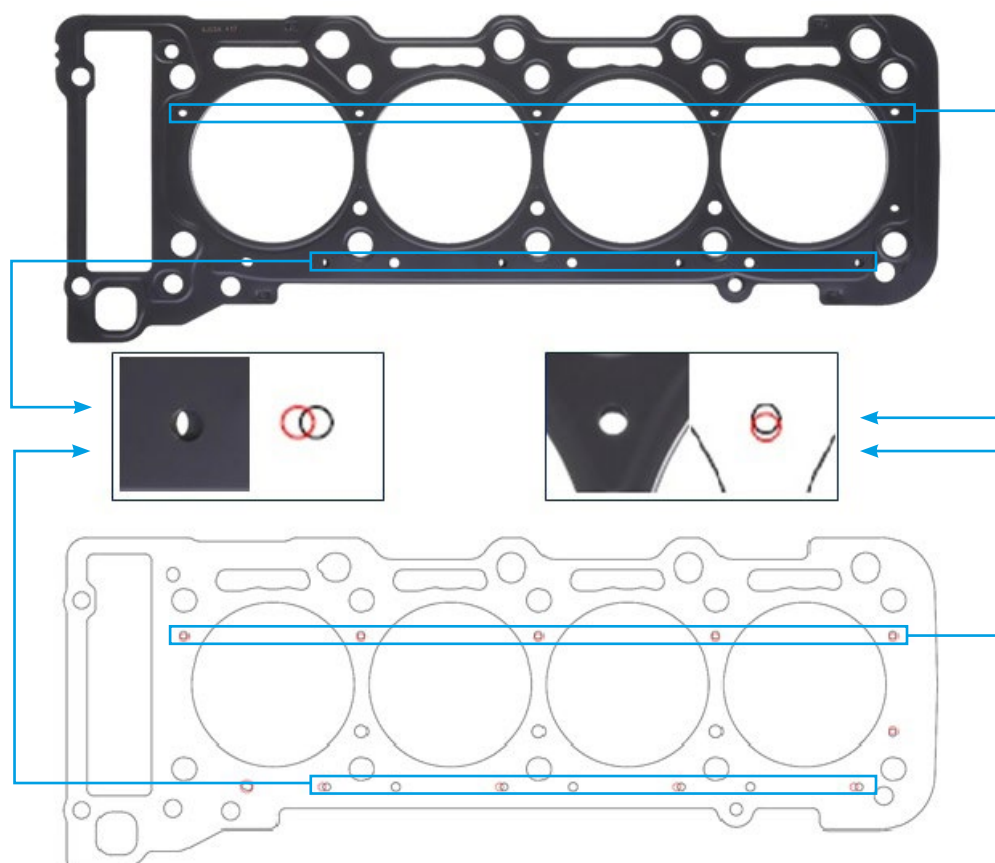
## DESIGNS THAT USUALLY LEAD TO CUSTOMER CONFUSION: 10188400

In this MLS gasket, **coolant holes** in all sheets are made with **the same diameter**, however disposition after assembling is misaligned some millimetres, this way the resulting hole is oval and smaller.

This fact usually makes the customer think that it is a manufacturing mistake, however the truth is that **it is designed on purpose** to improve engine cooling.

**New acquired** cylinder head gasket **must not be modified** in any case, since the coating can be damaged, holes may not have required dimensions, and damages in gasket materials can happen, affecting seriously to the tightness between engine block and cylinder head.

**Ajusa recommends** that before assembling the new gasket it **must be visually inspected** and compared with disassembled one, to verify that there have been no mistakes when selected in the catalog.
