TECHNICAL REPORT

Warning during assembly
process of rocker cover
gasket 11023900

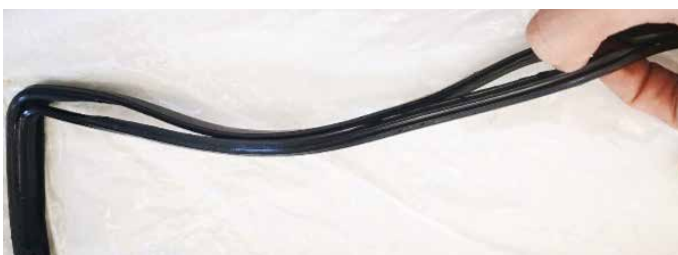
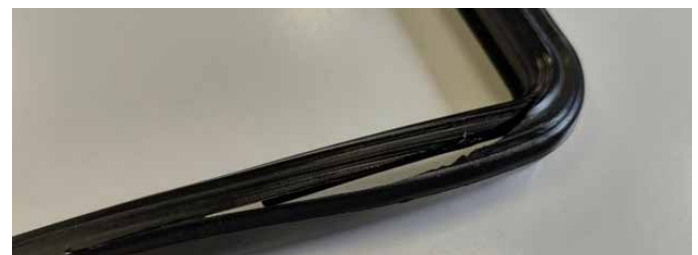
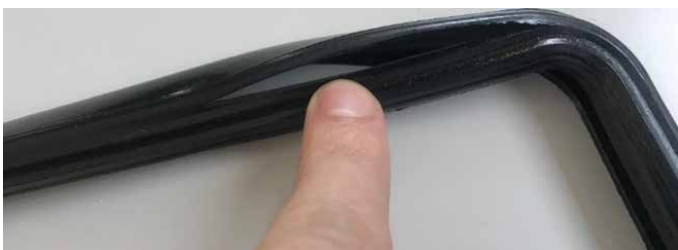
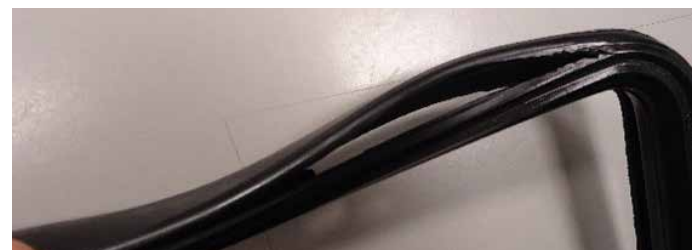
Next, we are going to show you some examples where we have been able to see **how gasket has been damaged** and cut after receiving an excessive torque.

An **excessive torque** or higher than recommended by the manual in each application might **damage or cut the rocker cover gasket** 11023900.
