# Electric EGR Valves (e.g. Renault, Opel)

## Stickiness at the valves

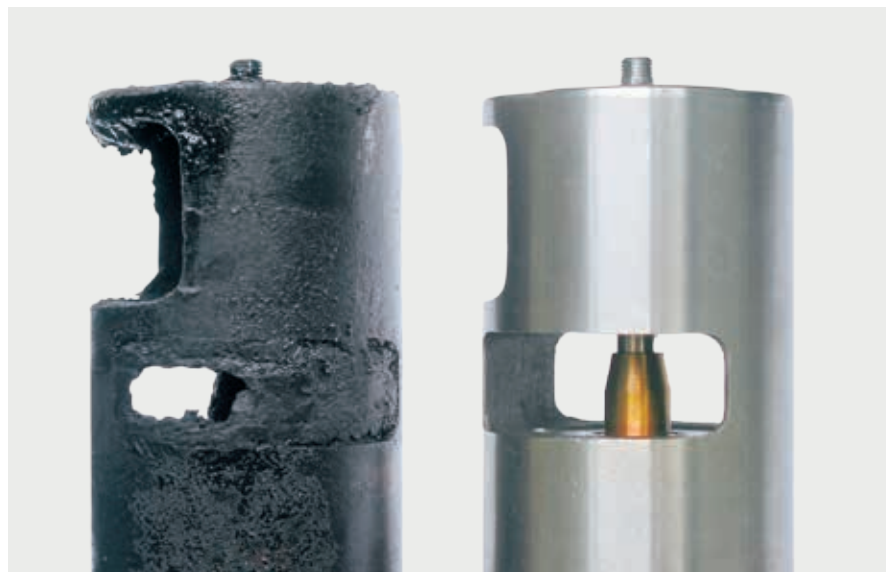
Through checks in the workshop the diagnosis "Malfunctioning EGR valve" was determined. The built-in electrical EGR valves suffer through oil-containing deposits.

- The valve is stiff.
- The valve is stuck and does not open.
- Due to the deposits the opening cross-section is reduced.
- The valve does not close fully.

*EGR valve with sticky deposits and EGR valve as new*

In the case of the EGR valves mentioned here, the most frequent causes of malfunctions are deposits at the valve disk or the valve seat. The EGR valve must be checked and replaced as required.

**We do not recommend cleaning the EGR valve; when doing so, it might be damaged.**

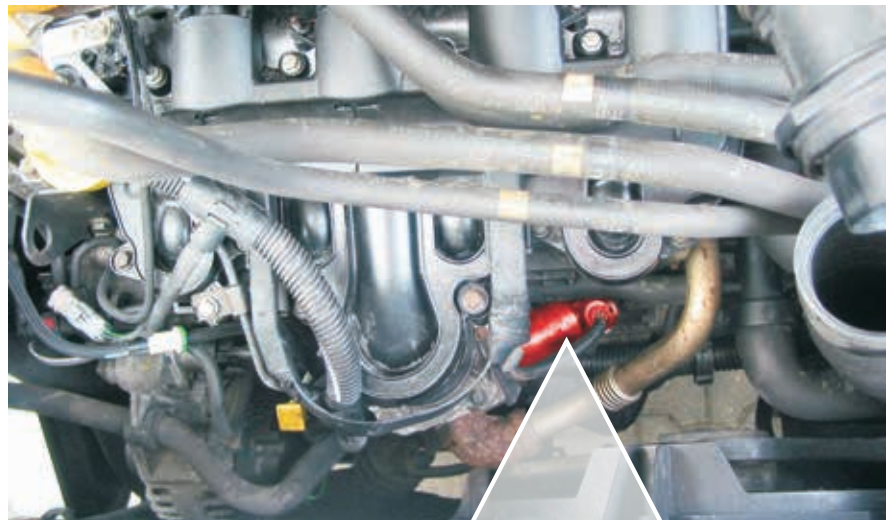
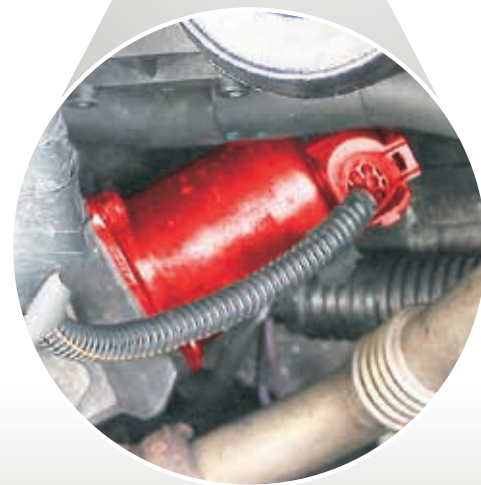
*EGR valve in the Renault Master JD1M (highlighted)*
