NISSENS' TECHNICAL TIPS AC Compressors

NISSENS NUMBER **89249**

MANUFACTURER VOLVO
MODEL SERIES 850
MODEL ALL MODELS
YEAR 1993-1999

PRODUCT SUBJECT CLUTCH PROBLEMS

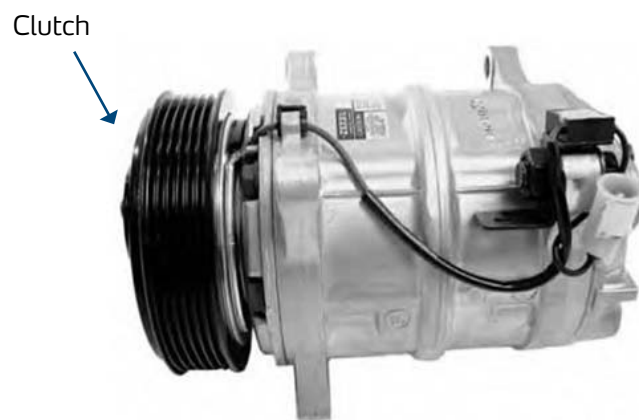
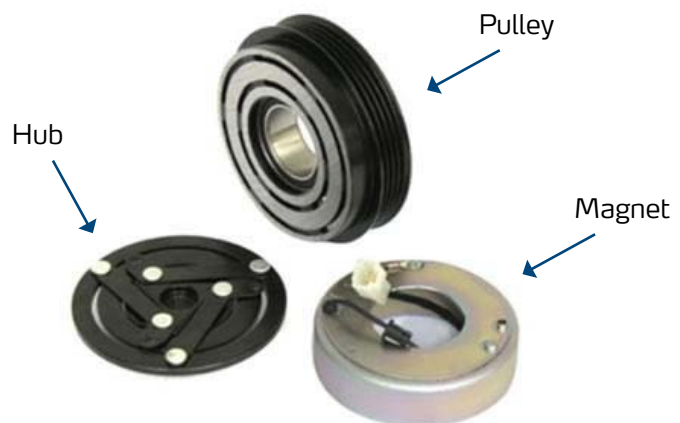
Most Volvo 850 models have problems with the clutch after a certain timeframe. The shims that ensure the distance between the hub and the pulley start to create problems. The distance increases over time, and the magnet will at the end not be able to engage the hub properly.

When the clutch is cold, there will be no problems. But once the pulley gets warm (after 2-5 minutes), the hub will disengage due to the increased distance.
