**SI 0082**  
For technical personnel only!  
1/2

# SERVICE INFORMATION

## ELECTRIC EGR VALVE (OPEL/VAUXHALL)

### STICKING / CARBON DEPOSITS ON THE VALVES

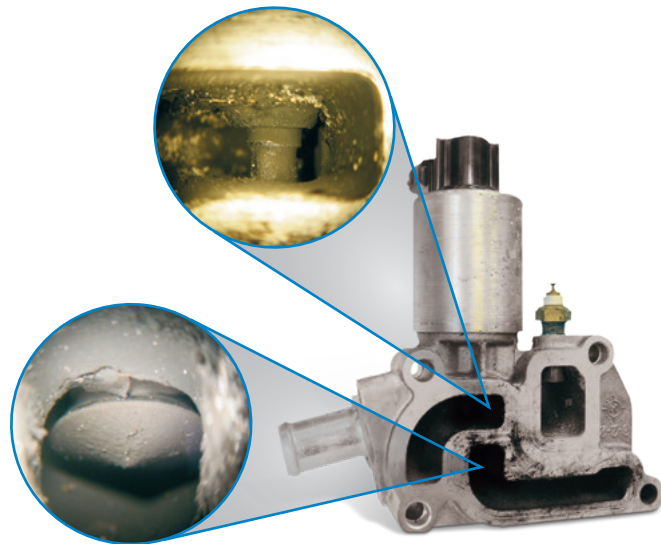
During checks in the repair shop, "Malfunction EGR valve" is identified in the diagnostics. The installed electric EGR valves are stuck/carbonised on the valve head or seat due to oily deposits.

- The opening cross-section of the EGR valve is reduced.
- The valve does not open or close completely.

Electric EGR valve cut

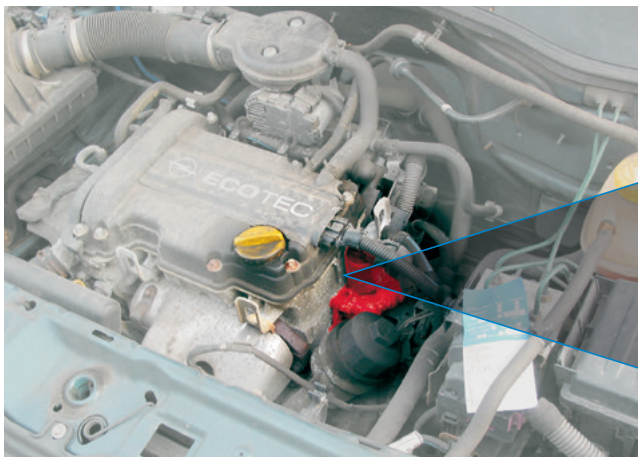
Electric EGR valve in the Opel Corsa (highlighted)

For the EGR valves listed here, the most frequent causes of malfunctions are deposits on the valve head or valve seat. The EGR valve must be checked and replaced if necessary.
