## 93037, 93061, 93070, 93102, 93121, 93132

CITROËN / FIAT / FORD / MAZDA / MINI / PEUGEOT / VOLVO

### ISSUE POSSIBLE OIL FLOW RESTRICTIONS

## PRE-FILTER INSIDE THE OIL FEED LINE

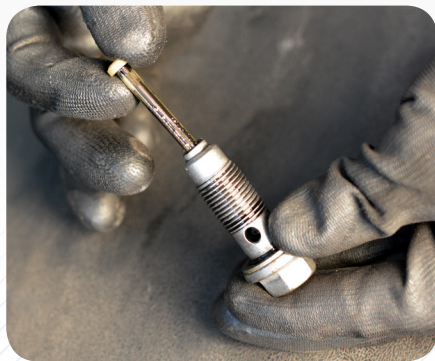
In some vehicle models, with the listed diesel engines, there is a factory installed pre-filter in the oil feed line to the turbo. The filter is mounted in the coupling on the engine side either as an insert filter or as a filter integrated with the banjo bolt. The very fine mesh of the filter makes it easy to clog it up due to impurities present in the oil (e.g. carbonized, hardened oil particles). The filter/mesh can also get loosened due to disintegrating from the coupling/banjo bolt. In both cases, it will cause feed oil flow restrictions. Consequently, the shaft lubrication gets impaired, resulting in serious failures of the turbo.

Removing the pre-filter from the oil feed line coupling

- **Depending on the OE version: Remove the factory-installed pre-filter from the oil feed line coupling or install a new banjo bolt without the filter**
- **Replace the oil feed line**
- **Perform engine flushing/cleaning to eliminate any sludge/carbonized oil particles**

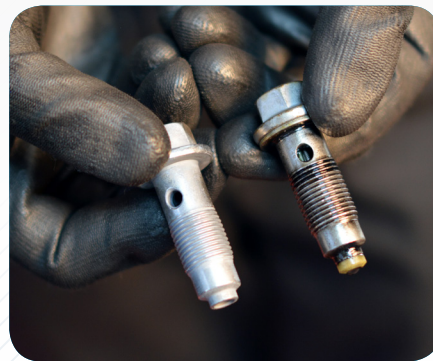
OE banjo bolt (right) with the filter and a new one to be used without filter (left)
