In response to complaints relating to turbochargers always also check the surroundings

Vehicle	Product	PIERBURG No.
Various, turbocharged	Electropneumatic pressure converters (EPW) Electric switchover valves (EUV) Vacuum pumps	see catalogue/TecDoc CD

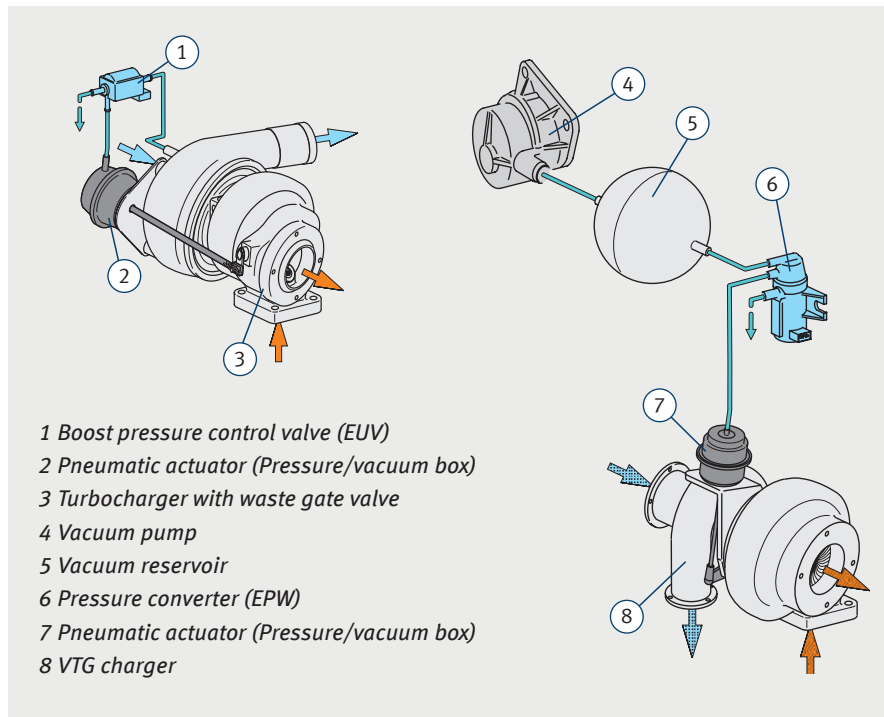
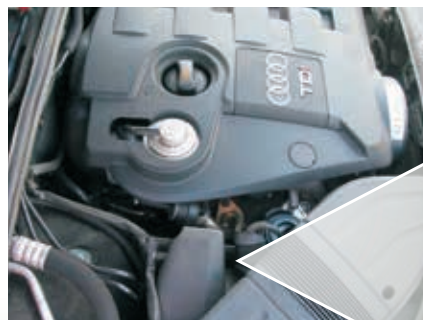
Fig.: VTG charger and EPW (highlighted in red) in the Audi A4 TDI

In the case of complaints which point to the turbocharger being at fault, always the components around it must also be checked.
