TECHNICAL REPORT

Assembly recommendations
for the cylinder head gasket
55013000

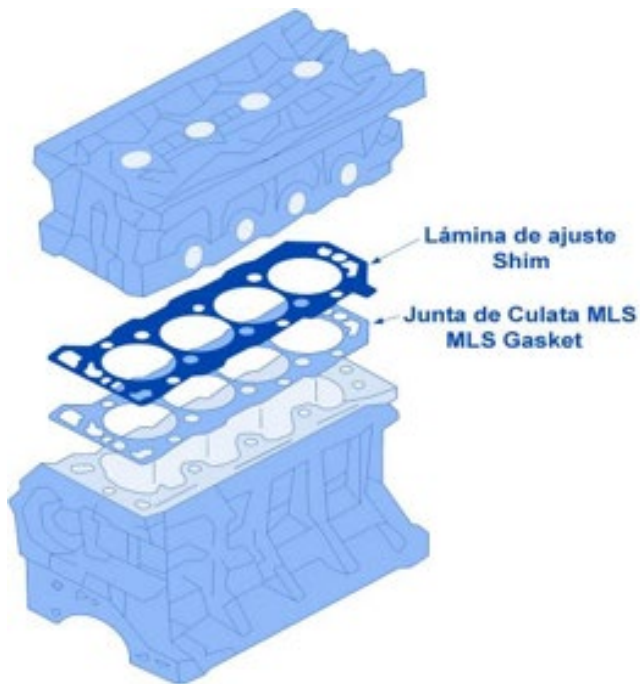
The **adjustment blade** (Shim), must be positioned above the cylinder head gasket as we show in the following figure:

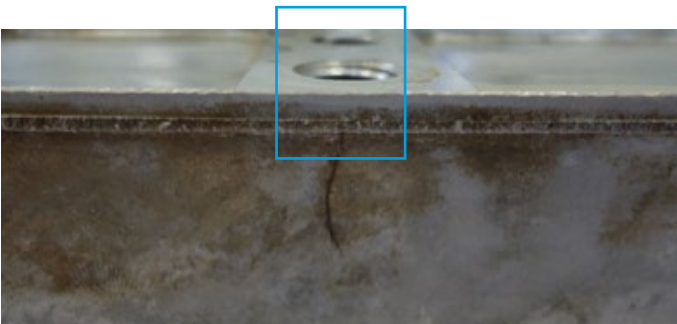
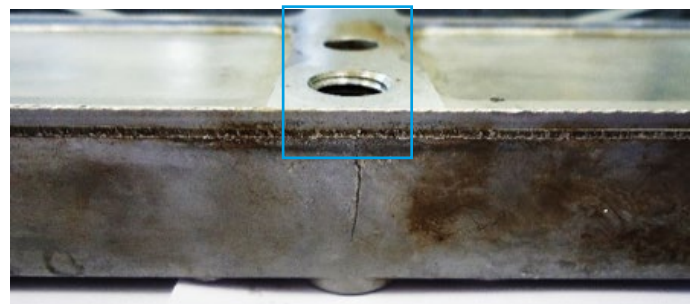
For these characteristics, it is possible that when the head gasket is replaced, the screw housing is not in the best conditions, and **may even be fractured**, and the necessary tightening is not achieved to ensure leak tightness.

In the following pictures we can see an oil duct after normal tightening, in **which cracks have appeared in the zones of greater tension**, which are the screw steps

For this reason, when **replacing this oil rail when we perform the head gasket repair**, we will ensure the perfect condition of the bolt housing and with that correct tightening of the cylinder head bolts.
