**SERVICEINFO**

**STEERING KNUCKLE**

AIC article no.: 57202 / OE reference no.: 4001 462 75R

## Expandable: Not every steering knuckle breaks

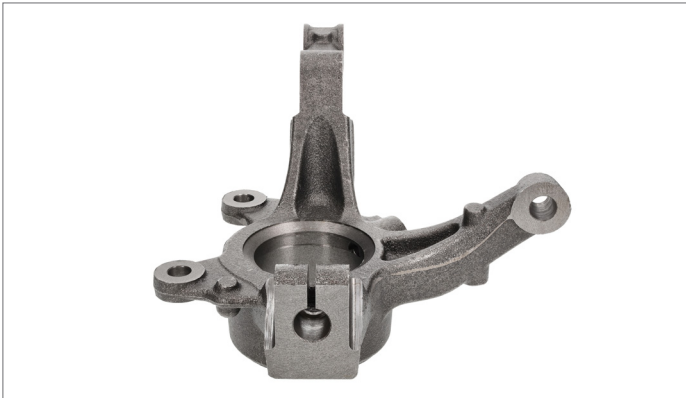
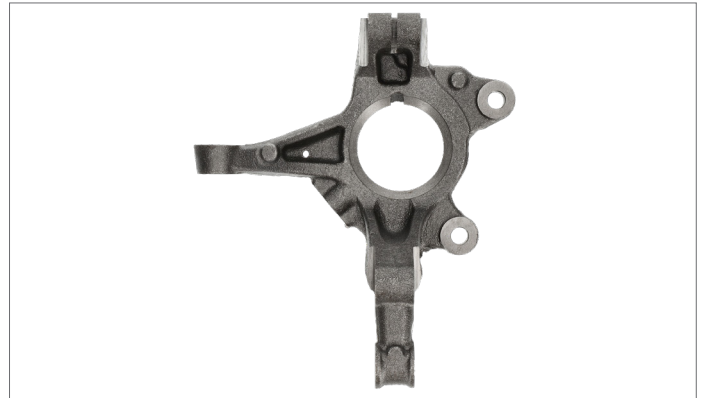
AIC art.no.: 57202 | OE ref. no.: 4001 462 75R

Accidents with effects on the axle geometry and thus a limited steering stability as well as changed grip of the tyres cannot be seen with the naked eye.

Among the vehicle parts that are particularly affected by this are steering knuckles, which can warp. Such damage is particularly possible in the event of accidents and sometimes even unfortunate encounters of the vehicle, for example with high kerbs or potholes.

As a consequence, the axle geometry must be checked and, if necessary, axle parts replaced.

- Never heat the stub axle parts to loosen stuck screws.  
This will change the metal structure of the stub axle!
- Always check the axle geometry when replacing the stub axle and correct it if necessary.
- Check with a test drive the correct alignment of the steering wheel, as well as the steering behaviour.
