SERVICEINFO

AIC Germany
Automotive Components

BLOWER MOTOR RESISTORS WITH THERMAL FUSES

AIC article no.: 53118 / Oe reference no.: 1K0 959 263A

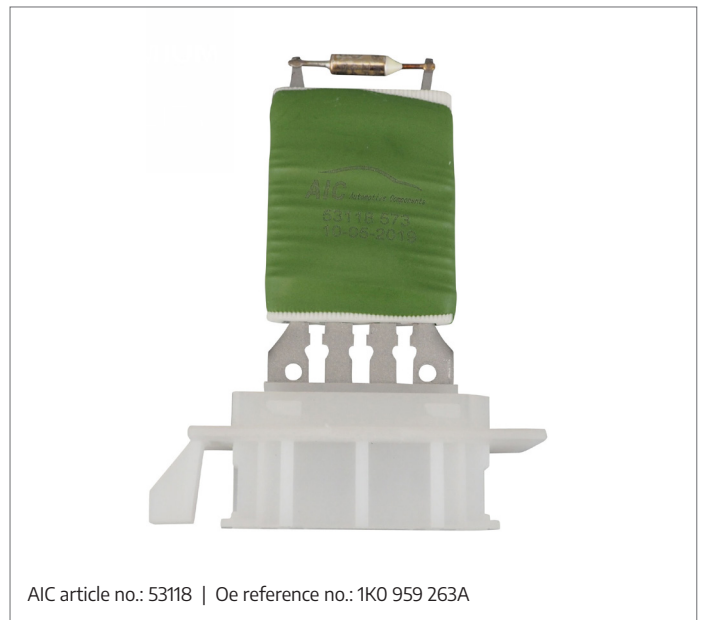
AIC article no.: 53118 | Oe reference no.: 1K0 959 263A

When replacing a blower motor resistor, make sure that the cause of the failure is correctly identified. This might be a clogged air intake or a sluggish blower motor. Thermal damage is easy to spot due to discolouration at the affected area.

Upon a failure of the blower, it is often **only the resistor that is replaced**. While the blower will work again following the replacement of the resistor, **the cause of the problem will still not have been rectified. It is therefore only a matter of time before problems recommence and the fuse activates again, meaning the blower will only work at full speed or not at all.**
