**SERVICEINFO**

**CYLINDER HEAD COVER**

AIC article no.: 57251 / Oe reference no.: 1112 7 565 284

Causes of wear of the cylinder head cover

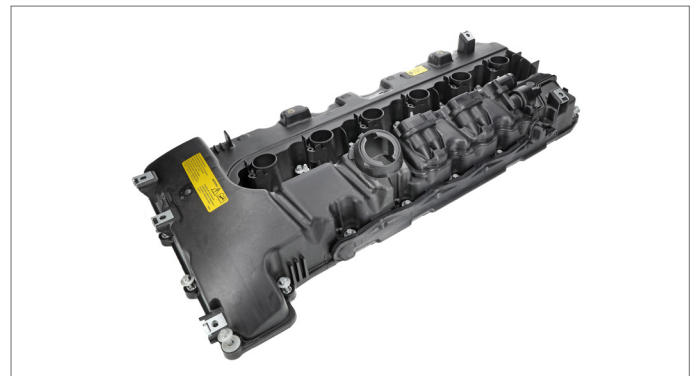
AIC article no.: 57251 | Oe reference no.: 1112 7 565 284

The following things could be related to a defective cylinder head cover:

- the vehicle leaks oil
- oil smell in running condition
- engine runs unevenly

To blame for the above-mentioned anomalies are usually:

- a leaky seal
- clogged valves for crankcase ventilation
- tearing of the cylinder head cover receptacles due to aging or incorrect assembly

If you notice any of the above damage to the cylinder head cover, do not hesitate to replace it with a new one. In most cases, the repair of the hood also includes the replacement of the seals. If these signs are ignored, the vehicle may even suffer engine damage in extreme cases.
