MINI Timing Chain Replacement

An engine with a rattle that could not be ignored

Timing chain kit replacement procedure

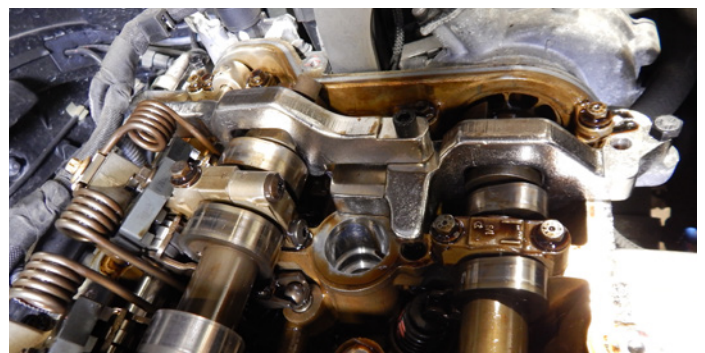
Figure 3

Subsequently, the camshaft-locking tools can be fitted to the camshafts - ensure both the cam and crankshaft are set in the correct position before removing the timing chain. (Fig.3)

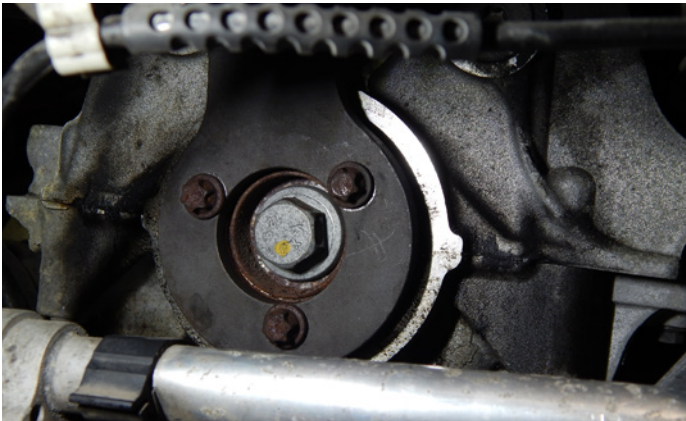
Figure 4

Next, the crankshaft counter hold tool can be attached before undoing the crankshaft- hub retaining bolt. (Fig.4)

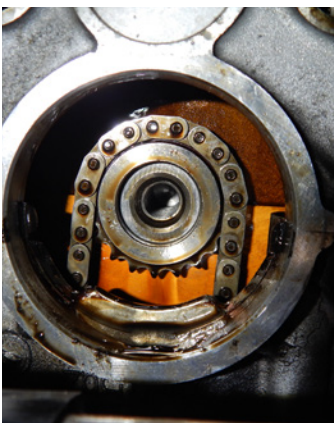
Figure 5

Undo and discard the bolt, then remove the tool. Remove the two chain guide bolts ready for the timing chain to be taken out from the top of the engine. Remove the VVT retaining bolts and carefully remove the sprockets from the camshafts, while supporting the timing chain. With an assistant, carefully remove the crankshaft hub - this hub unit slides into the drive sprockets to retain the engine timing and the oil pump drive. Therefore, the oil pump drive sprocket must remain in place on the crankshaft. If the sprocket falls into the sump, the sump will have to be removed. (Fig.5) With the chain free, slide the timing chain with the guides and the crankshaft sprocket up and out of the engine, leaving the oil pump drive in place.

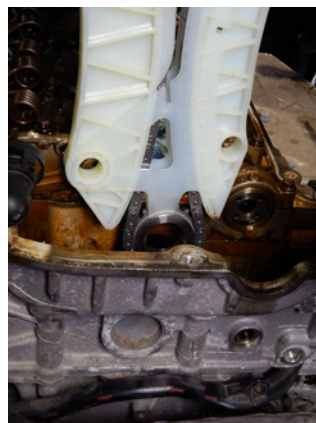
Figure 6

Assemble the left and right guide rails and then slide the chain into place with the crankshaft sprocket. Afterwards, these assembled parts can carefully be lowered into the engine until the crankshaft sprocket is in line

with the crankshaft. The hub can then be slid through the sprocket and secured into place. (Fig.6)
