# Focus on Suspension

## Front Suspension

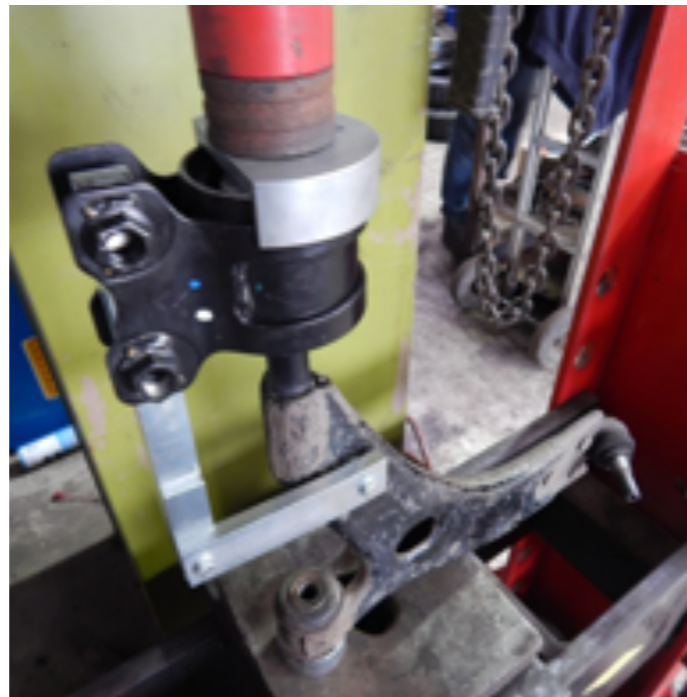
Fig. 2

Once the old worn bush is removed, clean the shaft, then the new bush should be pressed on; there is a special tool available to maintain the alignment of this, while the new bush is being pressed into position. (Fig 2)

The repaired arm can now be refitted to the vehicle. The bush (febi 32418) has applications for several other Ford, Mazda and Volvo models.

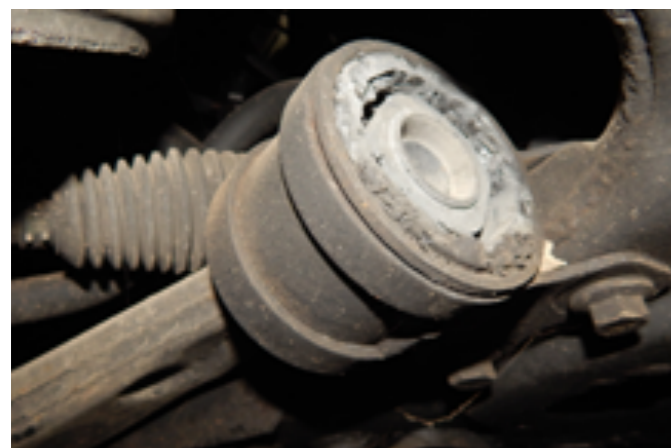
Fig. 1

One of the most common wear items on the MK 2 model is the track control arm bush, (Fig 1). This component is available as part of the complete arm or available as a separate part with new fixing bolts. The latter, is available from febi, and offers an economic repair of this component, compared with replacing the whole arm, which in most cases is perfectly serviceable.

When carrying out this replacement, the alignment of the new bush is very important. The bush needs to be aligned correctly on the shaft of the suspension arm for its correct operation and to ensure long life of the replacement component. The old bush can be pressed off or carefully cut off using suitable equipment, so as not to damage the shaft that the bush is mounted on.

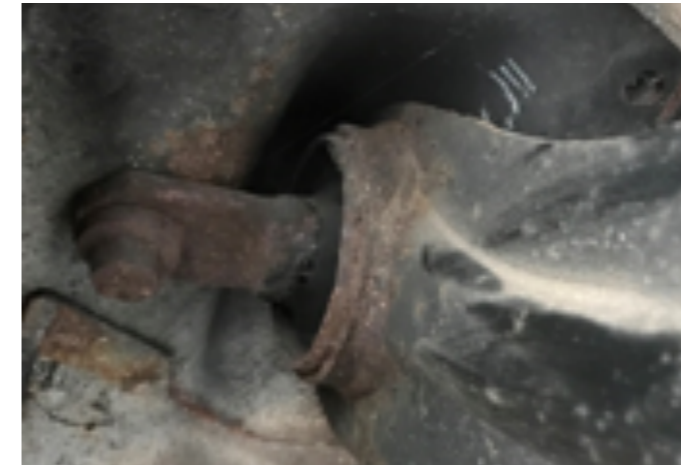
Fig. 3

The highly acclaimed control blade trailing arm multilink suspension system was developed for the Focus model; its compact design allows maximum use of space for luggage capacity and gives excellent handling. The thin trailing arm handles, fore and aft wheel location and brake-torque reaction, with three other links that are needed to fully locate the wheel. All these components have bushes that are prone to wear. The trailing arm bush (febi 34249), which is replaceable like the front control arm, needs to be aligned correctly during installation; otherwise the rubber will over twist and shorten the life of the bush. (Fig 3)

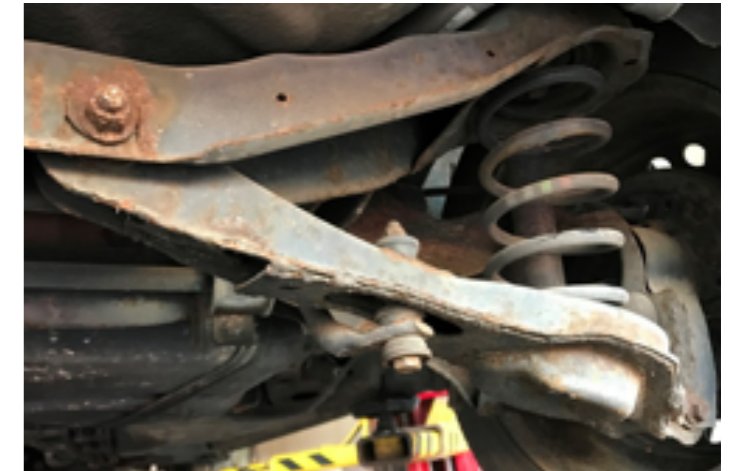
Fig. 4

The track control arm, which is located between the cross member and the knuckle, is prone to stress fractures which can lead to failure after long service. When this arm is removed to gain access to other components such as the road spring, or when it needs replacing, the fixing bolts are prone to corrosion. (Fig 4)

This leads to the bolts shearing during removal or being seized to the bush inner sleeve. Therefore, it may be necessary to cut them off in order to remove the arm.

The inner bolt, which is an eccentric bolt, is for camber adjustment, it must turn freely if it is to be adjusted. It is recommended that all bolt fixings are tightened only when the vehicles suspension is under load, not free hanging, as this puts unnecessary strain on the bushes and can lead to them being tightened in the incorrect position.
