In response to complaints relating to turbochargers always also check the surroundings

Vehicle	Product	PIERBURG No.
Various, turbocharged	Electropneumatic pressure converters (EPW) Electric switchover valves (EUV) Vacuum pumps	see catalogue/TecDoc CD

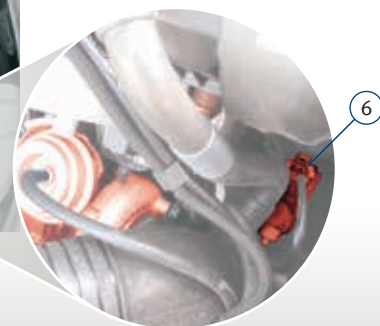
Fig.: VTG charger and EPW (highlighted in red) in the Audi A4 TDI

In the case of complaints which point to the turbocharger being at fault, always the components around it must also be checked.
