TECHNICAL REPORT

Assembly recommendations
for the cylinder head gasket
55013000

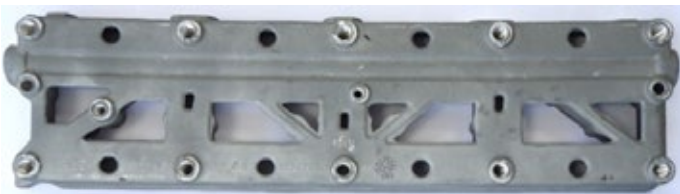
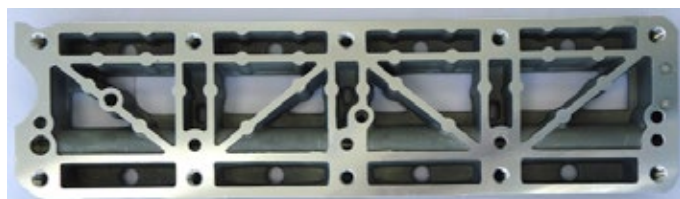
This oil rail which OE part number is LCN000140L, has 2 main functions:

- Distribute the engine oil between the cylinder head (1)
- Contains the threaded holes where we can screw the cylinder head bolts (2)

In addition of the design change in the head gasket, when such a cylinder head gasket is requested, Land Rover also recommends replacing one oil rail located in the lower part of the engine block

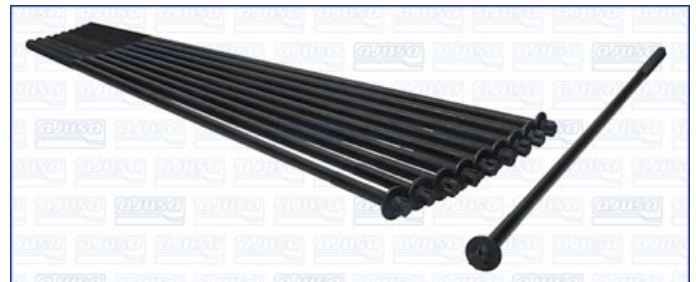
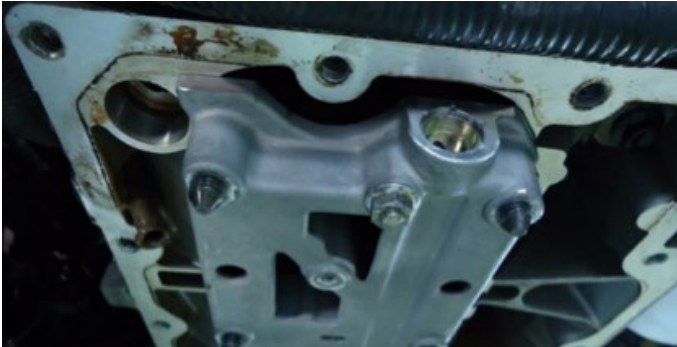
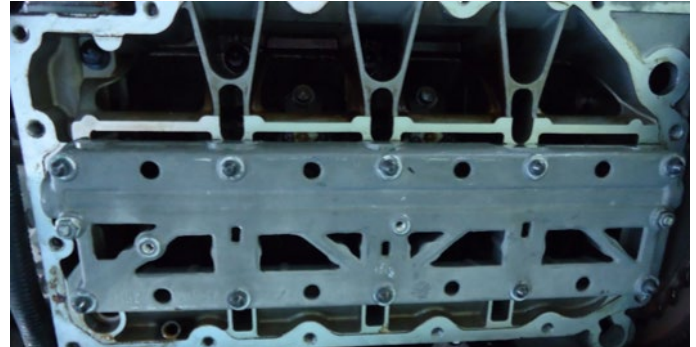
The fact that in this part where the screws are screwed is not common, since in almost all the motors are usually threaded directly in the motor block. For this reason, **the screws of these motors have a large length** to cross the entire motor block, and end in a small threaded area.

- 1) Reduced threaded area.
- 2) The manufactured material is an aluminum alloy with a low hardness.

For these characteristics, it is possible that when the head gasket is replaced, the screw housing is not in the best conditions, and **may even be fractured**, and the necessary tightening is not achieved to ensure leak tightness.

For this reason, when **replacing this oil rail when we perform the head gasket repair**, we will ensure the perfect condition of the bolt housing and with that correct tightening of the cylinder head bolts.
