Ride Height Adjustment

Mercedes E-class W211 / S211

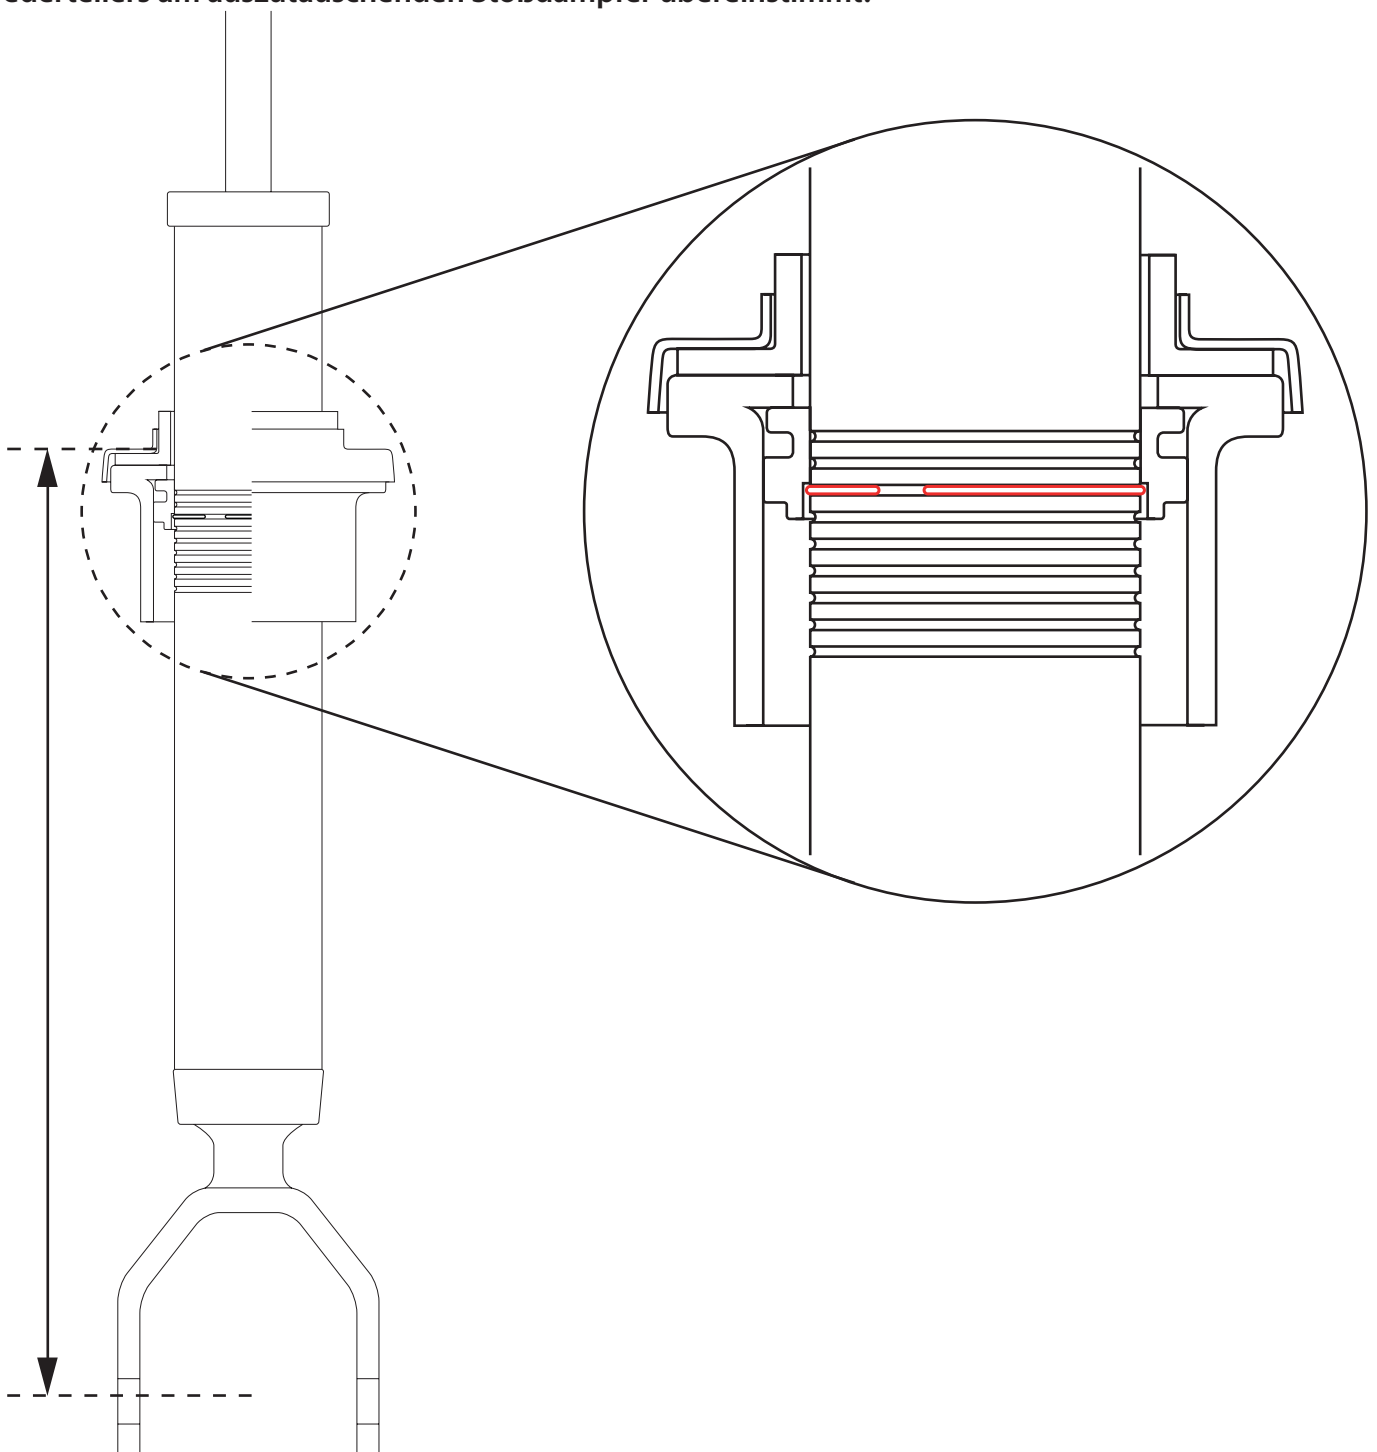
Nach dem Austausch der vorderen Schraubenfeder und des Stoßdämpfers beim Modell Mercedes E-Klasse W211/S211 kann das Fahrzeug eine falsche Höhe aufweisen.

Der Grund dafür ist, dass der untere Federteller des Stoßdämpfers nicht in der Höhe verstellt wurde.

Um den Federteller einzustellen, schieben Sie den Stützring (Sicherungsring) in die entsprechende Nut (siehe Bild). Der Stützring darf dabei nicht überdehnt werden.

Stellen Sie sicher, dass die Höhe des Federtellers am neuen Stoßdämpfer mit der Höhe des Federtellers am auszutauschenden Stoßdämpfer übereinstimmt.
